Accelerated Corrosion Test Results
CYNDAN Metal Protective Coating.

Qatar Petroleum (QP) contacted our Qatar distributor, Apollo LLC, seeking a solution to the corrosion of mild steel flanges used on oil rigs.

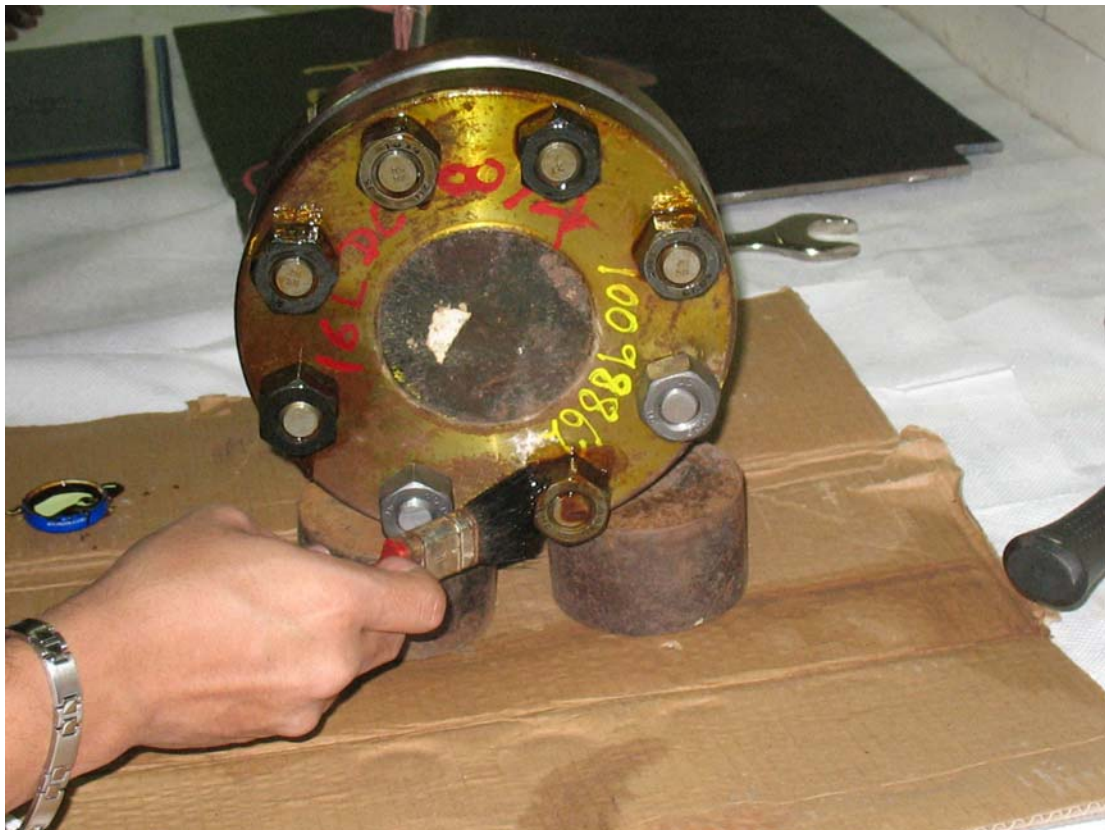
MPC was applied to a cleaned and dried second hand non corroded flange;

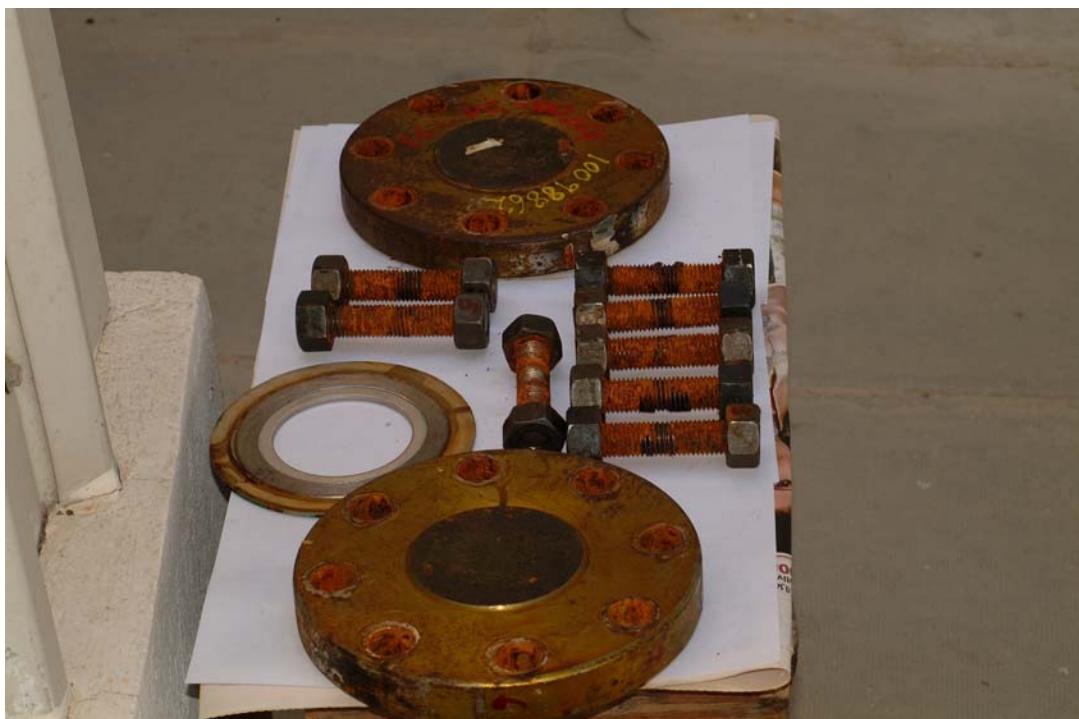
The exterior section of the dismantled flange:

Visibly the MPC treated sections offered excellent corrosion resistance to the flange sections it was applied to.

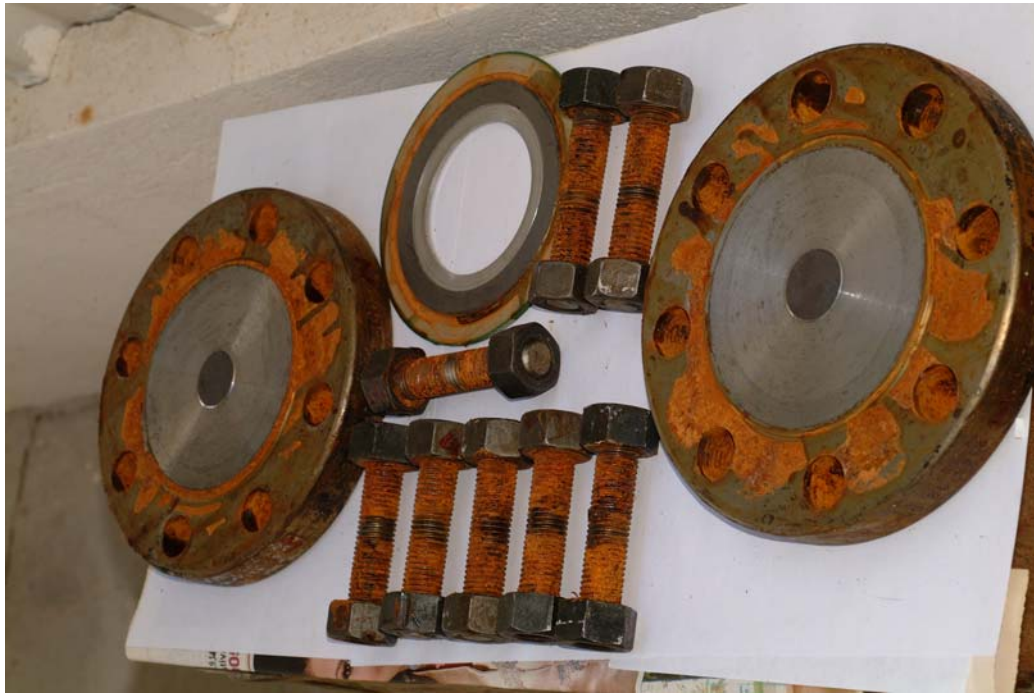
The interior section of the dismantled flange:

The sections it could not be applied to corrosion became visible after only 500 hours of testing.

To offer total corrosion assurance, the gap between the 2 flange sections including the unexposed bolt parts would need to be addressed. MPC could not be applied in situ to the internal areas of the flange.

It is proposed that a possible solution to this be that a thickened version of MPC be applied so as it bridges the gap between the flange sections hence not allowing air and water to corrode the internals.

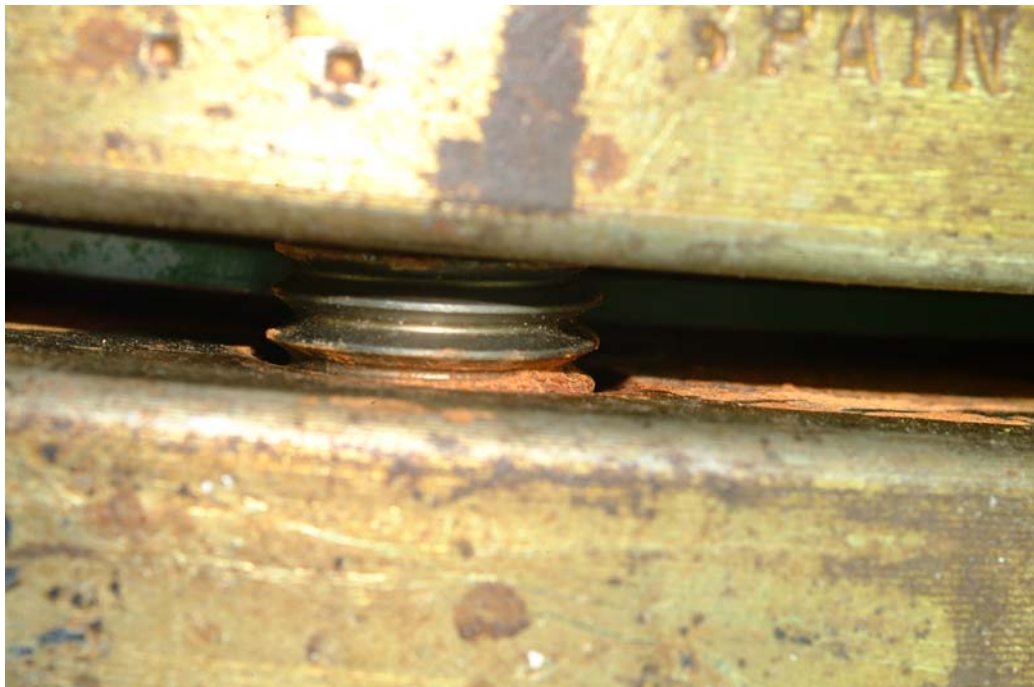
A cross section of the flange after salt test:
